Product Safety Notice – Evolution Floodlight

Full description of problem

Chalmit Lighting has identified a potential problem relating to DNA branded power factor correction capacitors fitted within the Evolution Ex'de' Zone 1 range of luminaires.

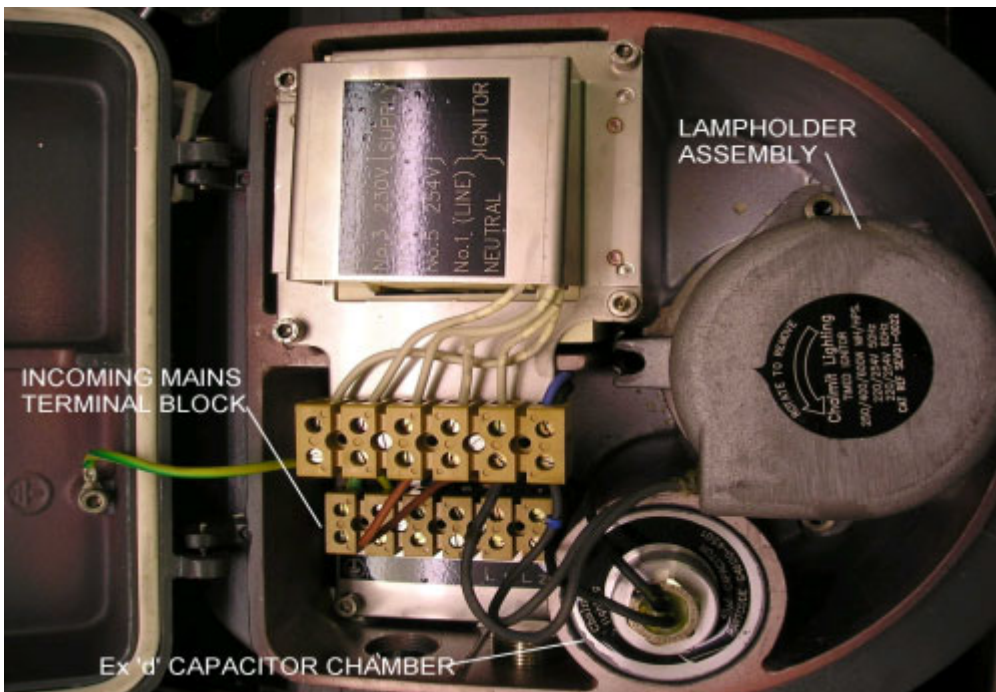
The Chalmit Evolution has an Ex'e' chamber at one end of the luminaire. This chamber contains the mains incoming terminals, the ballast and electrical connections. It also affords access to the lampholder assembly and the power factor correction capacitor which is enclosed within an Ex'd' chamber. See figure 3 below.

Under certain conditions the power factor correction capacitor can fail within its Ex'd' screwed flame path enclosure inside the Ex'e' chamber. The most likely cause of failure is thought to be abnormal voltage conditions out-with the specified operating parameters. Extensive testing has been carried out on both new and aged capacitors under laboratory conditions and the results are consistent with this theory.

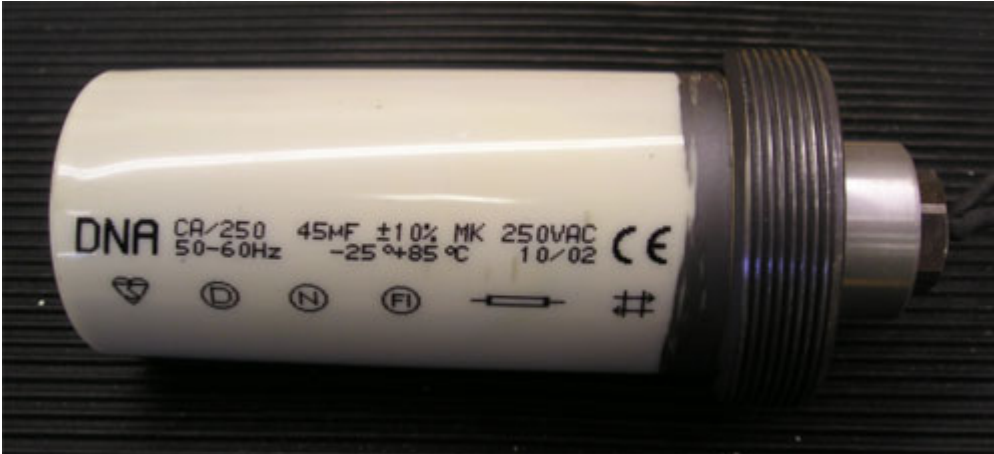
The DNA capacitor in question is of the self healing type and is encapsulated within a plastic case which in turn is assembled onto the capacitor cap. This cap has a threaded flamepath which is screwed into the capacitor housing. See figure 4 below.

In the case of the three destructive failures, the electrical connection was not severed and the heat build up caused pyrolysis of the polymeric carrier. The pyrolysed film ruptured through the plastic case of the capacitor. If this occurs near the top of the capacitor then this material can block the threads of the flameproof cap preventing venting of any pressure being built up within the chamber.

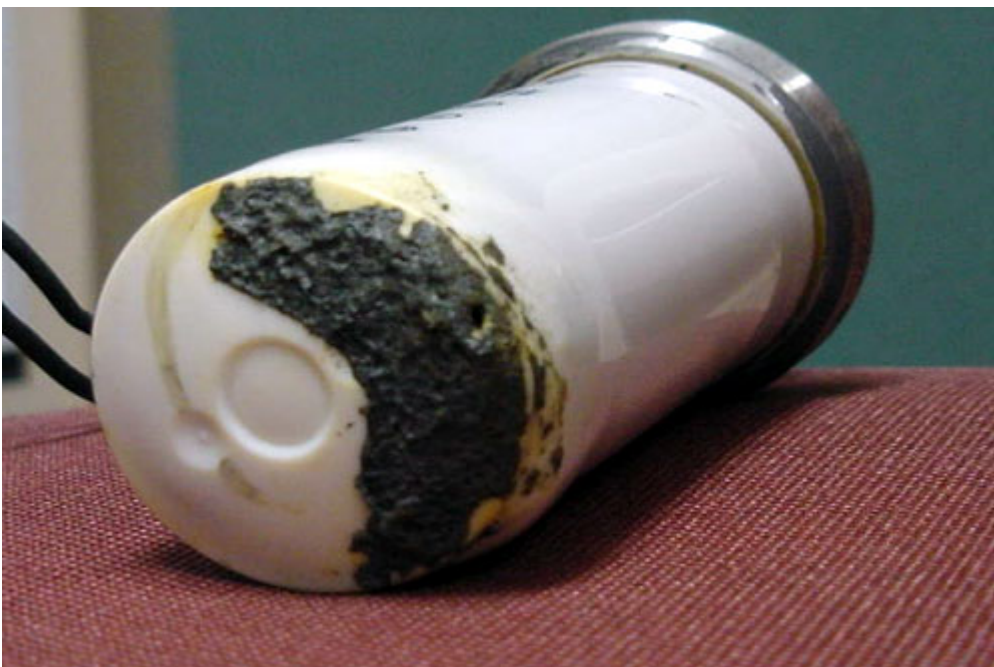
figure 5

Where the capacitor has failed passively, this causes the metalised film within the capacitor to short circuit. Heat generated by this allows the encapsulation material to expand and flow from the plastic case as shown in figure 5.

Generally the short circuit will either self heal or will fail safe due to the electrical connection breaking at the film connection. This has been the experience in the majority of cases with the exception of the three destructive failures.
